Park County

HIGH HAZARD LOCATION STUDY

Robert Peccia &
Associates

December 1982

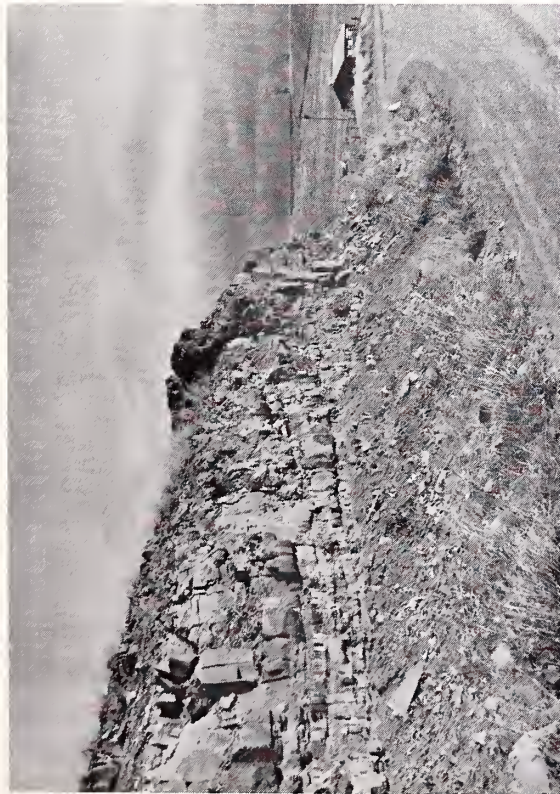
Rock outcrops at several locations along the Brackett Creek Road constitute roadside obstructions and limit sight distance.

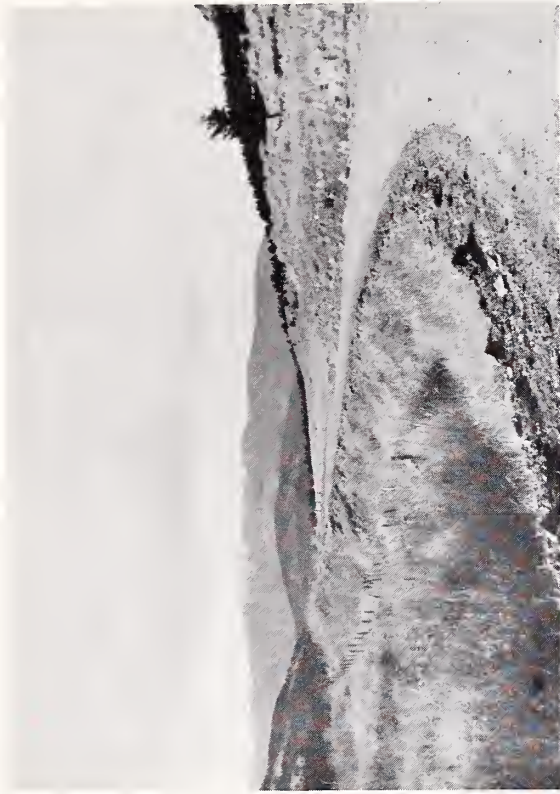
Typical series of curves within the site. Note steep areas adjacent to the roadway and the gently rolling terrain common to the area.

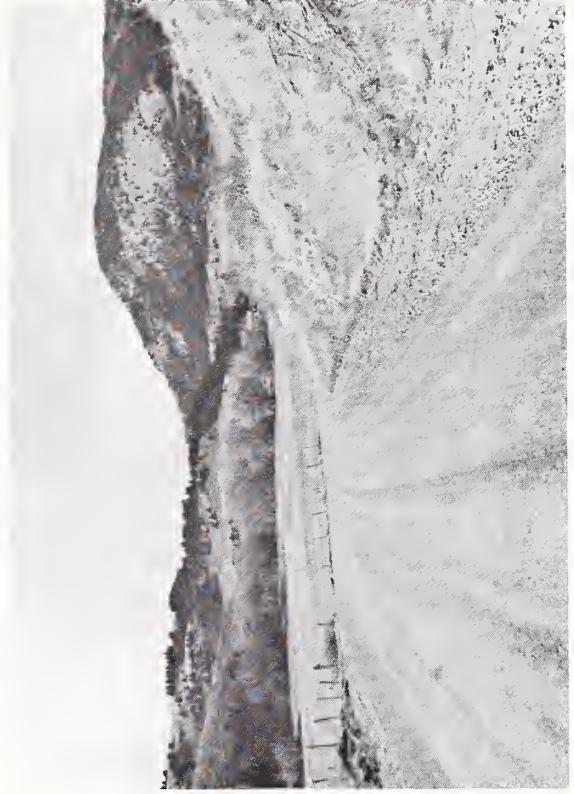
One of several areas within the site where terrain, changes in alignment, and roadside vegetation limit sight distance.

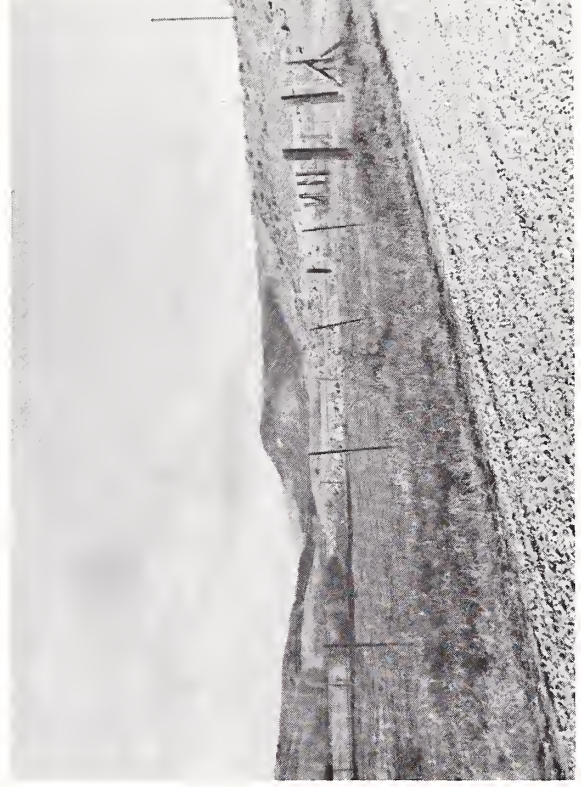
View of curve improvements from the east approach. Note the excess material placed along the outside of the curve.

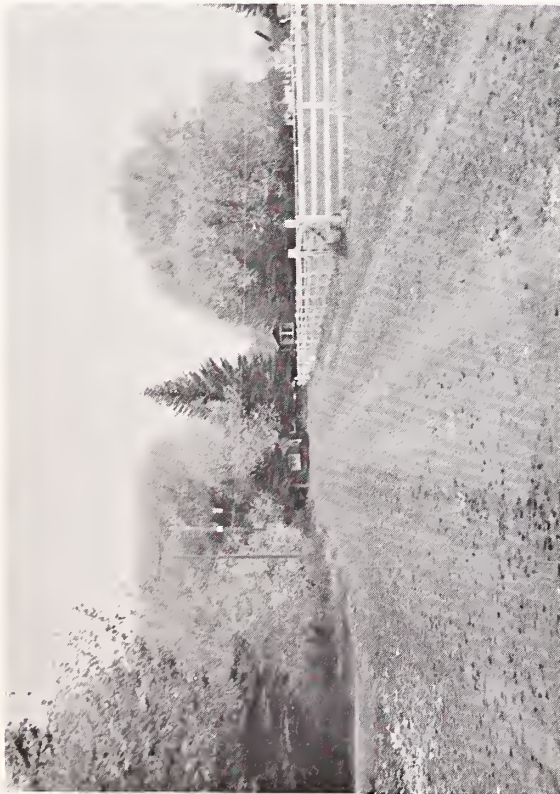
View of east approach to site. Note the location of power poles and fence in relation to the roadway edges.

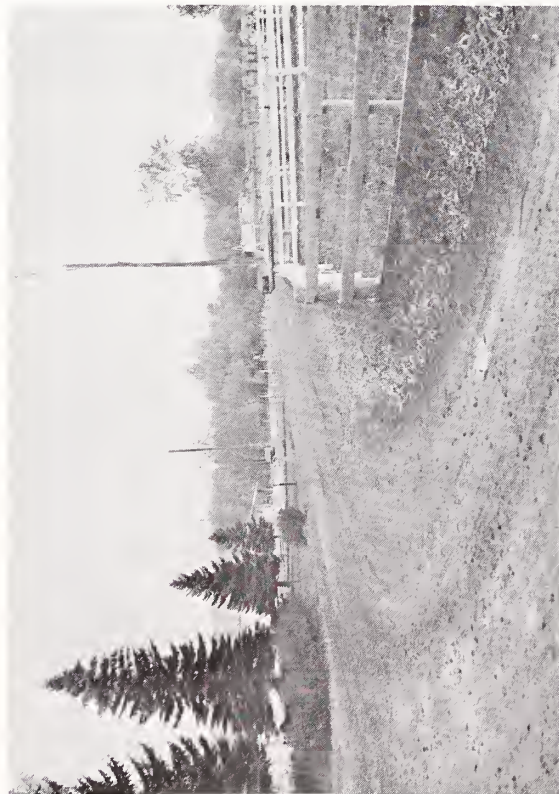
Looking north along Swainson Drive. Note the proximity of fence posts to travel lanes. Actual travel lane narrows to about 15 feet through the corner.

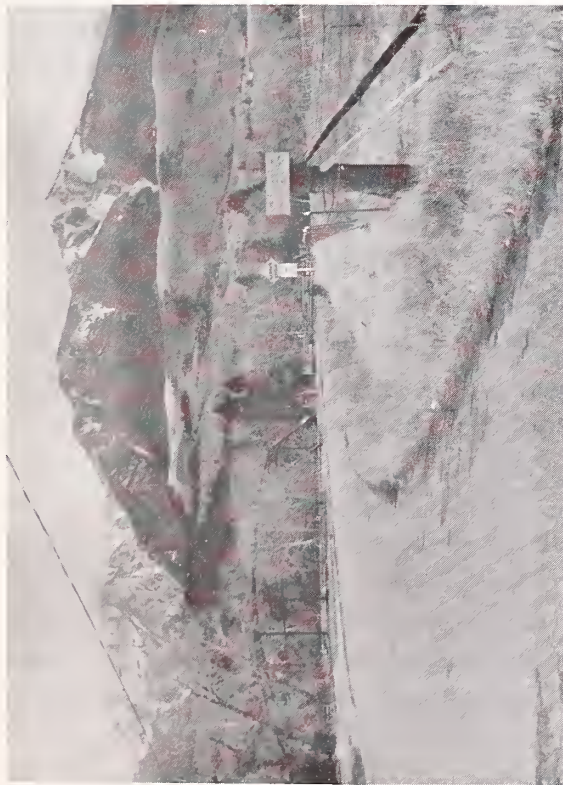
View of west approach to the Pine Creek Bridge. Note change in road alignment and signing.

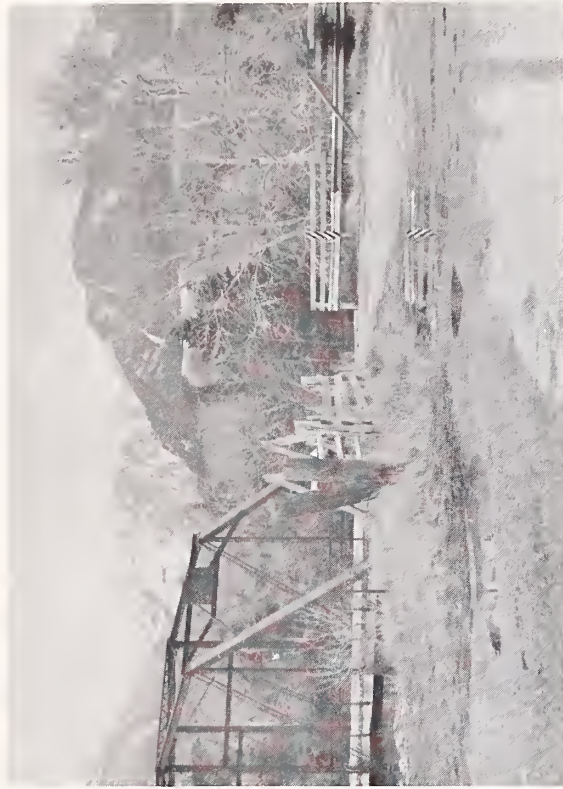
View of existing conditions at the west end of the bridge. Note the deteriorated pavement condition and flat superelevation at this location.

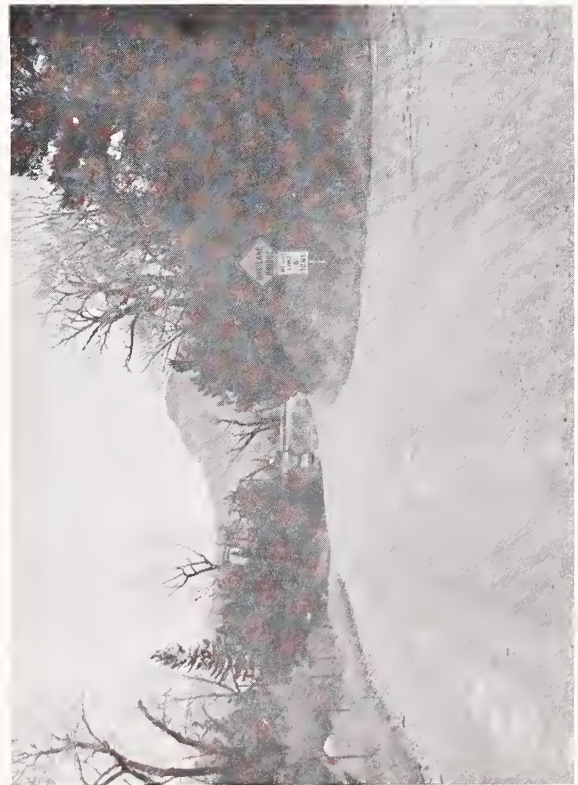
View of the east approach to the bridge. Note steep area adjacent to roadway near the bridge.

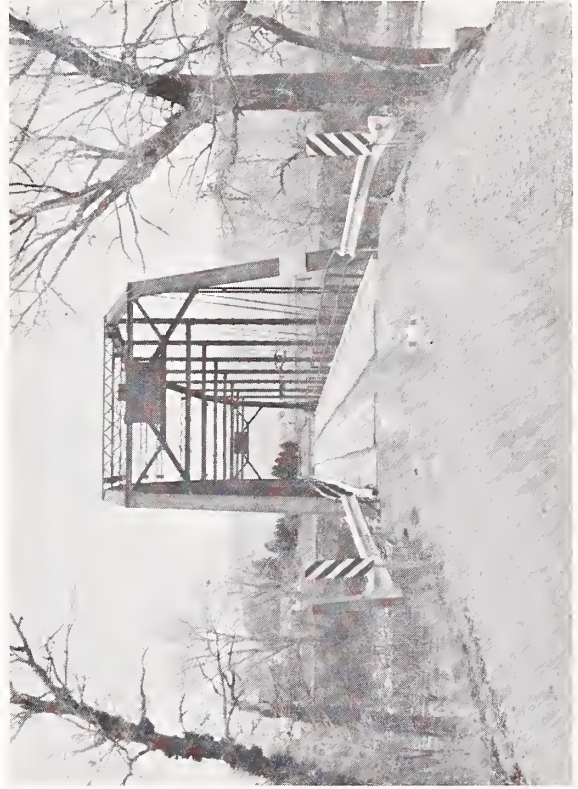
Looking westward across the Pine Creek Bridge. The bridge, built in 1910, is 16 feet wide and 235 feet long.

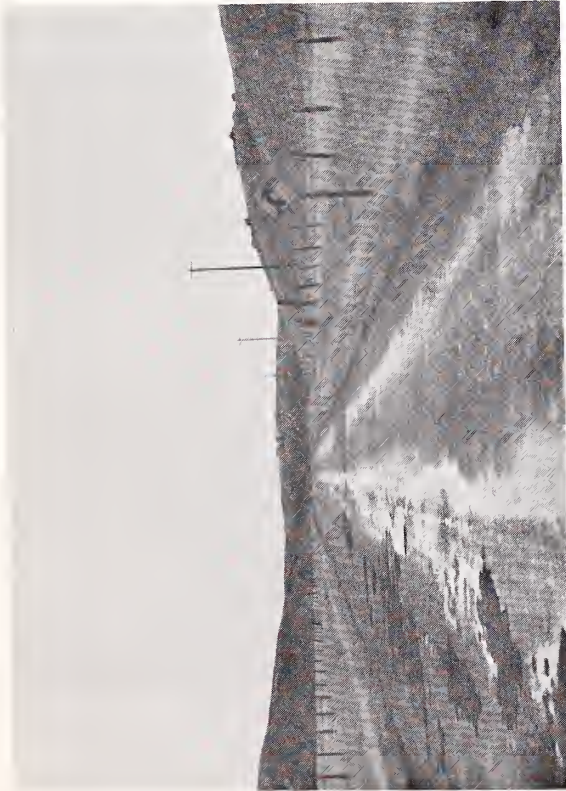
View of north approach to the intersection. Note pavement condition and existing signing.

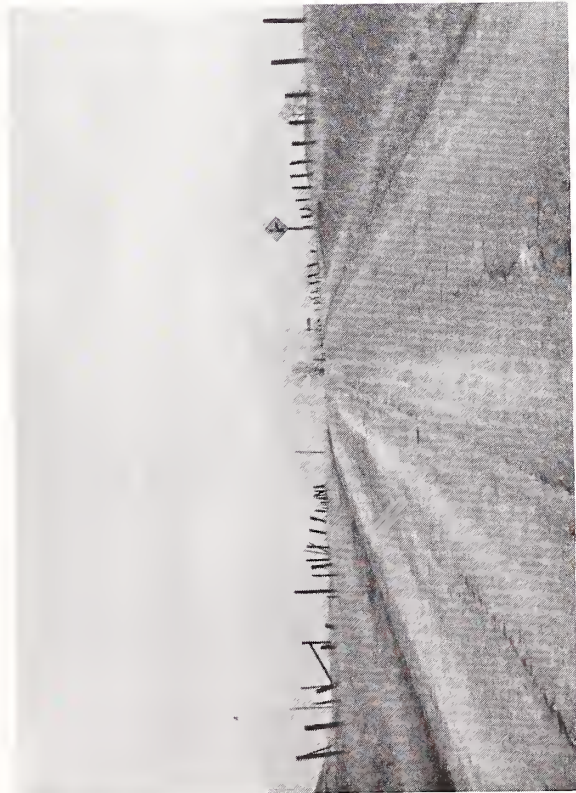
View of southern approach to the intersection. Slight grade at this location makes identification of the intersection difficult.

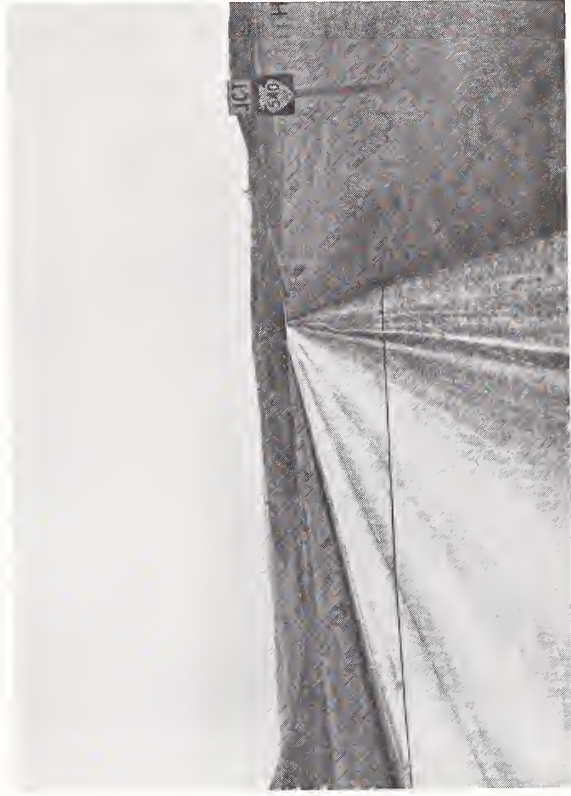
View of east approach to the intersection. Travel speeds on this approach are quite high due to the good condition of the roadway surface and the alignment.

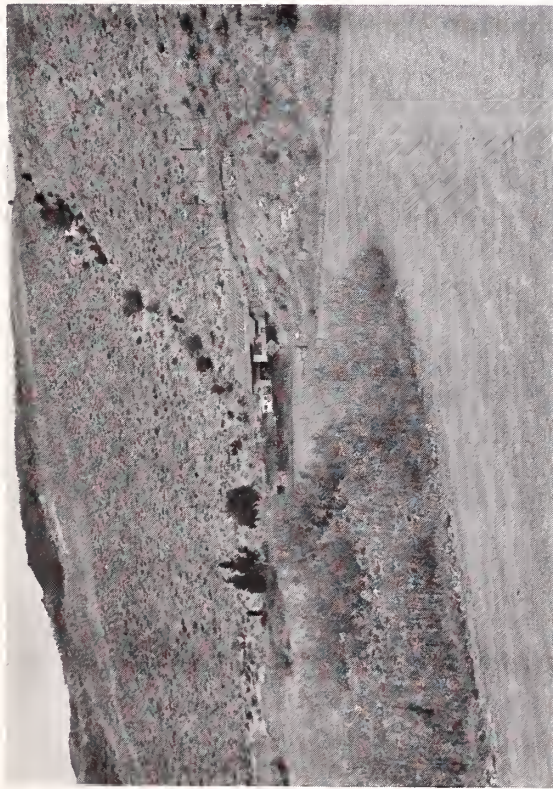
View of west approach to the hairpin curve at Site 5. Note "School Bus Stop Ahead" sign in the curve.

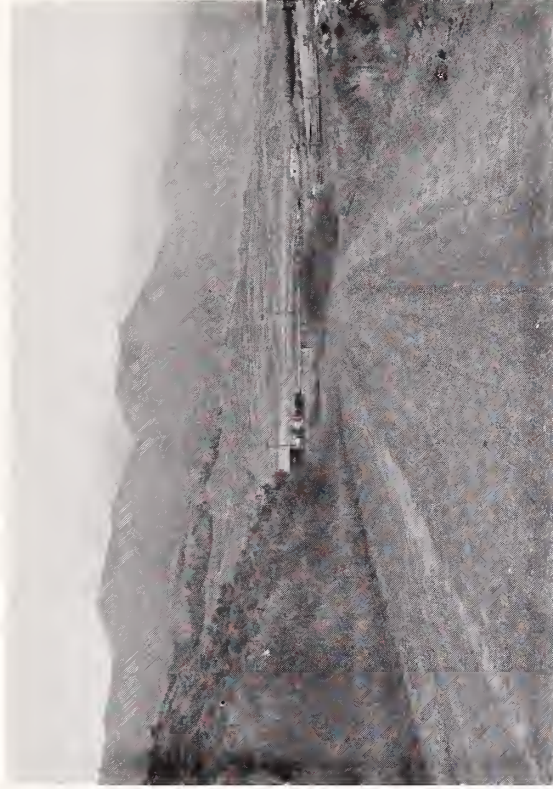
View of east approach to the curve. Note lack of curve warning signing or curve delineation.

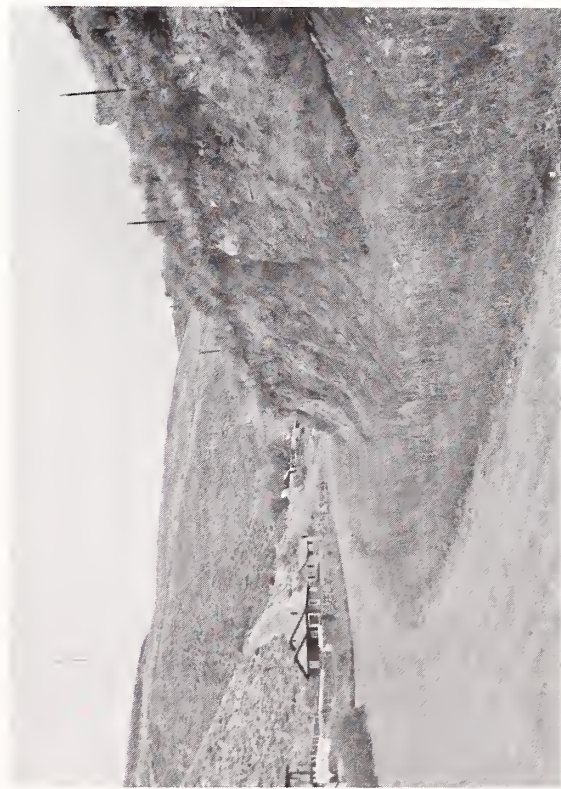
View of east approach to the site. Note the location of fencing and the steep bank.

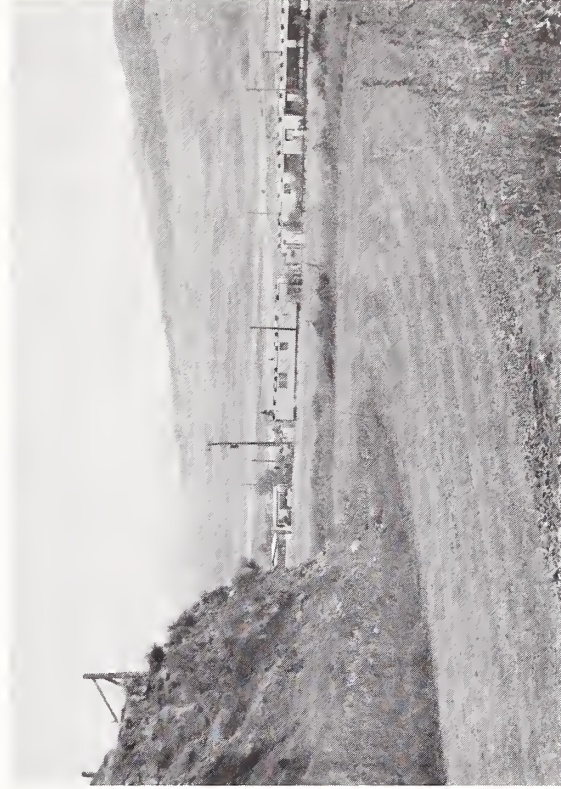
Sight distance in the curve is limited to about 100 feet due to the change in roadway alignment and terrain.

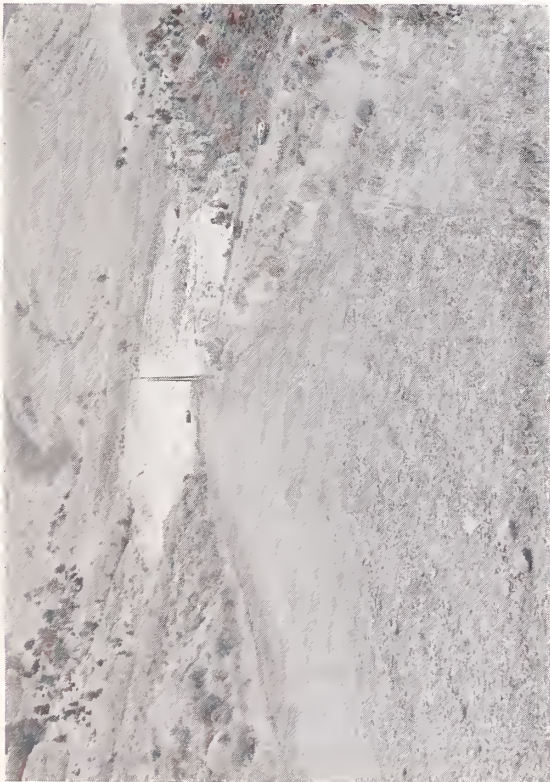
View of steep portion of the Jardine Road northeast of Gardiner. Grades exceed 8 percent at this location.

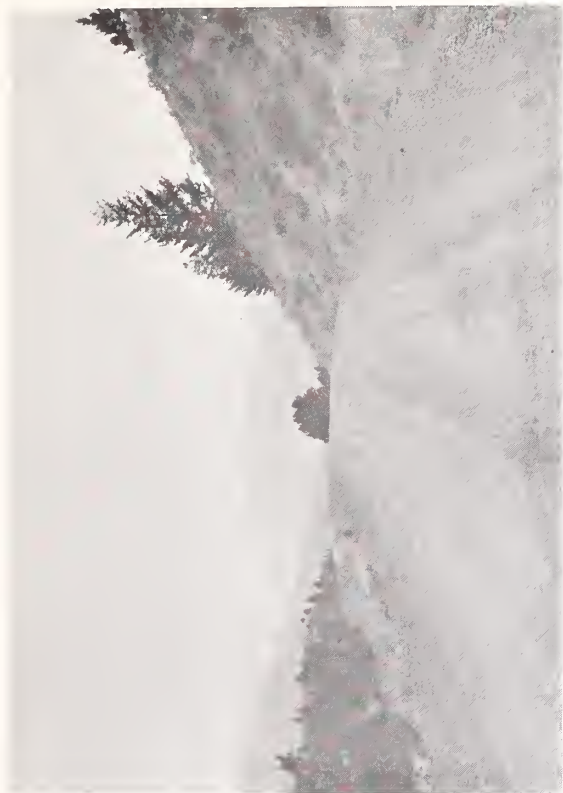
Typical area of restricted sight distance caused by a sharp change in grade and roadway alignment.
